Coastal Protection and Restoration Authority of Louisiana

2010/2011 Annual Inspection Report

EAST SABINE LAKE HYDROLOGIC RESTORATION PROJECT (CS-32)

October 6, 2010
May 10, 2011
Cameron Parish

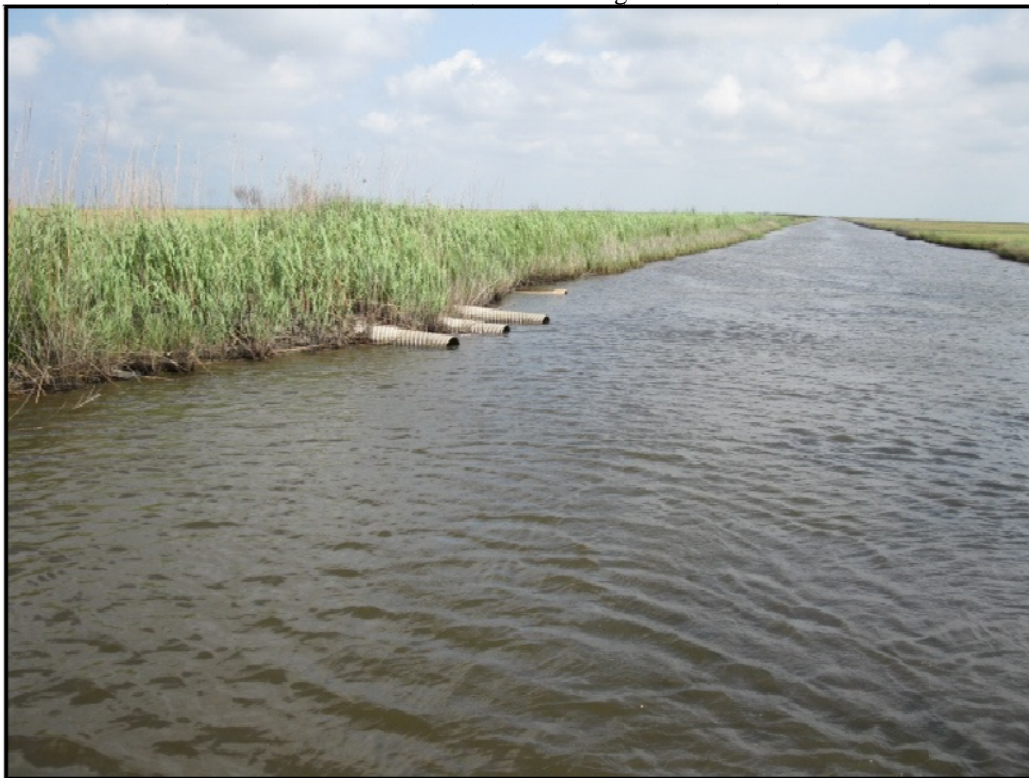
Photo No. 4 – Bridge Bayou Culverts

The culverts at this location are in good condition. No erosion was evident at this site. There was difficulty in getting to and from this site by cabin boat. Future inspections will require the use of an airboat. (Photos: Appendix B, Photo 4).

Item	Condition	Physical Damage	Corrosion	Photo #	Observations and Remarks
Bridge Bayou Culverts	Good			4	Culverts don't appear to be functioning and allow minimal water passage.
Steel Grating	N/A				
Stop Logs	N/A				
Hardware	N/A				
Timber Piles	N/A				
Timber Wales	N/A				
Galv. Pile Caps	N/A				
Pines Ridge Weir	Good			3	
Signage / Supports	Good				
Foreshore Rock Dike	Good			1,2	
Earthen Terraces	Fair				The condition of the vegetative plantings varied throughout with approximately 50% establishment on average. Salinity ranged between 7.4 - 9.7 ppt
